Manhole Inspection Summary

Manhole # S15GG2004MH

Insp Date: **7/7/06 1:27 PM**

Location Address: **1801 THORNBURY RD**

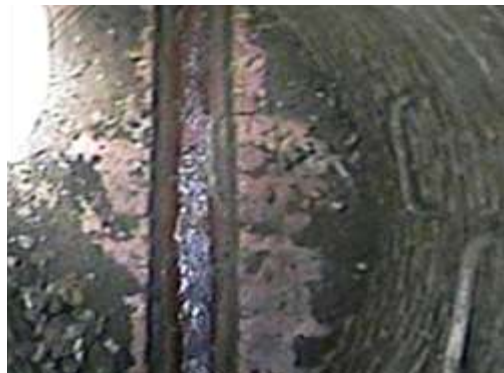
Top View

Steps Count: **4** Missing: **0** ☒ **Corroded**

Surcharge ☒ **Evidence Of Surcharge** Depth: **2** (ft.) ☐ Active Surcharge Present

Corroded steps. Evidence of surcharge - Bench debris.

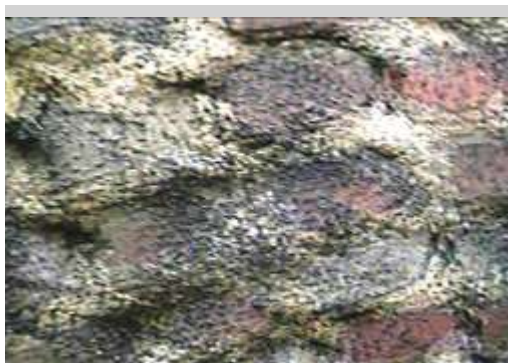
Defect

Condition: ☐ Sound ☐ Cracked ☐ Root Intrusion ☐ Loose Brick ☒ **Deteriorated**

Corbel deterioration and infiltration.

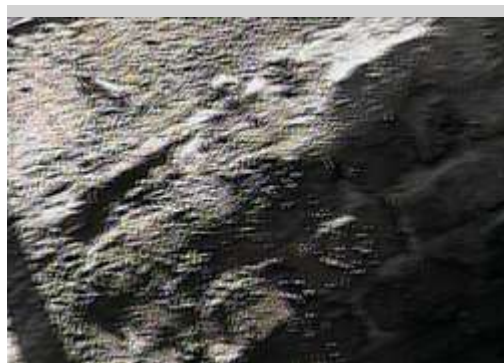
Defect

☒ **Leaks**

Condition: ☐ Sound ☐ Cracked ☐ Root Intrusion ☐ Loose Brick ☒ **Deteriorated**

Infiltration: ☐ None ☒ **Joint** ☐ Cracks ☒ **Mortar** ☐ Roots ☒ **Wall**

Frame leaks. Adjustment deterioration and infiltration.

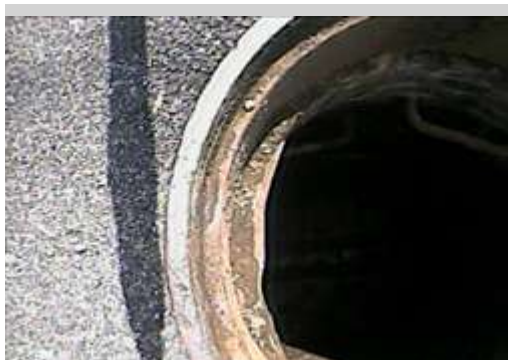
Defect

Frame Offset: **2** (in.)

Frame offset.

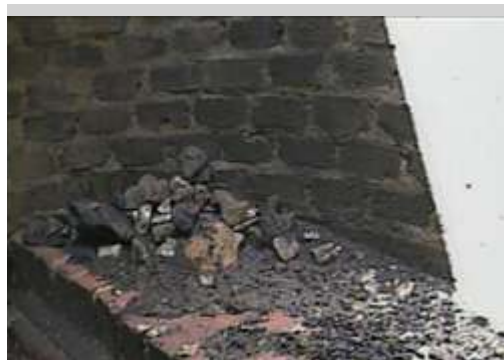
Defect

Infiltration: ☐ None ☐ Joint ☐ Cracks ☒ **Mortar** ☐ Roots ☐ Wall

Barrel infiltration. Bench debris.

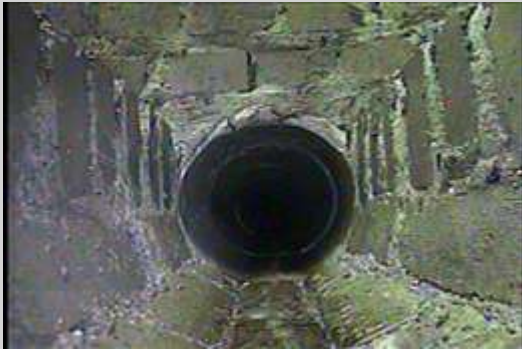
8 in. Circular Gravity Sewer Pipe Out @ 12 O'Clock

Infiltration: **Evidence**

Pipe Seal Cond: **Cracked**

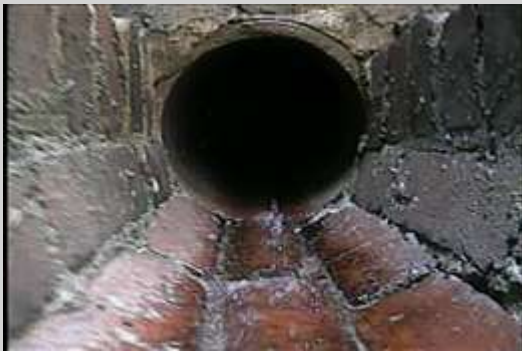
8 in. Circular Gravity Sewer Pipe In @ 6 O'Clock

Channel deterioration.

Infiltration: **Evidence**

Pipe Seal Cond: **Cracked**
